Chapter Two

Regional Erosion and Revegetation Assessment - Task Two

Erosion and Revegetation Site Analyses

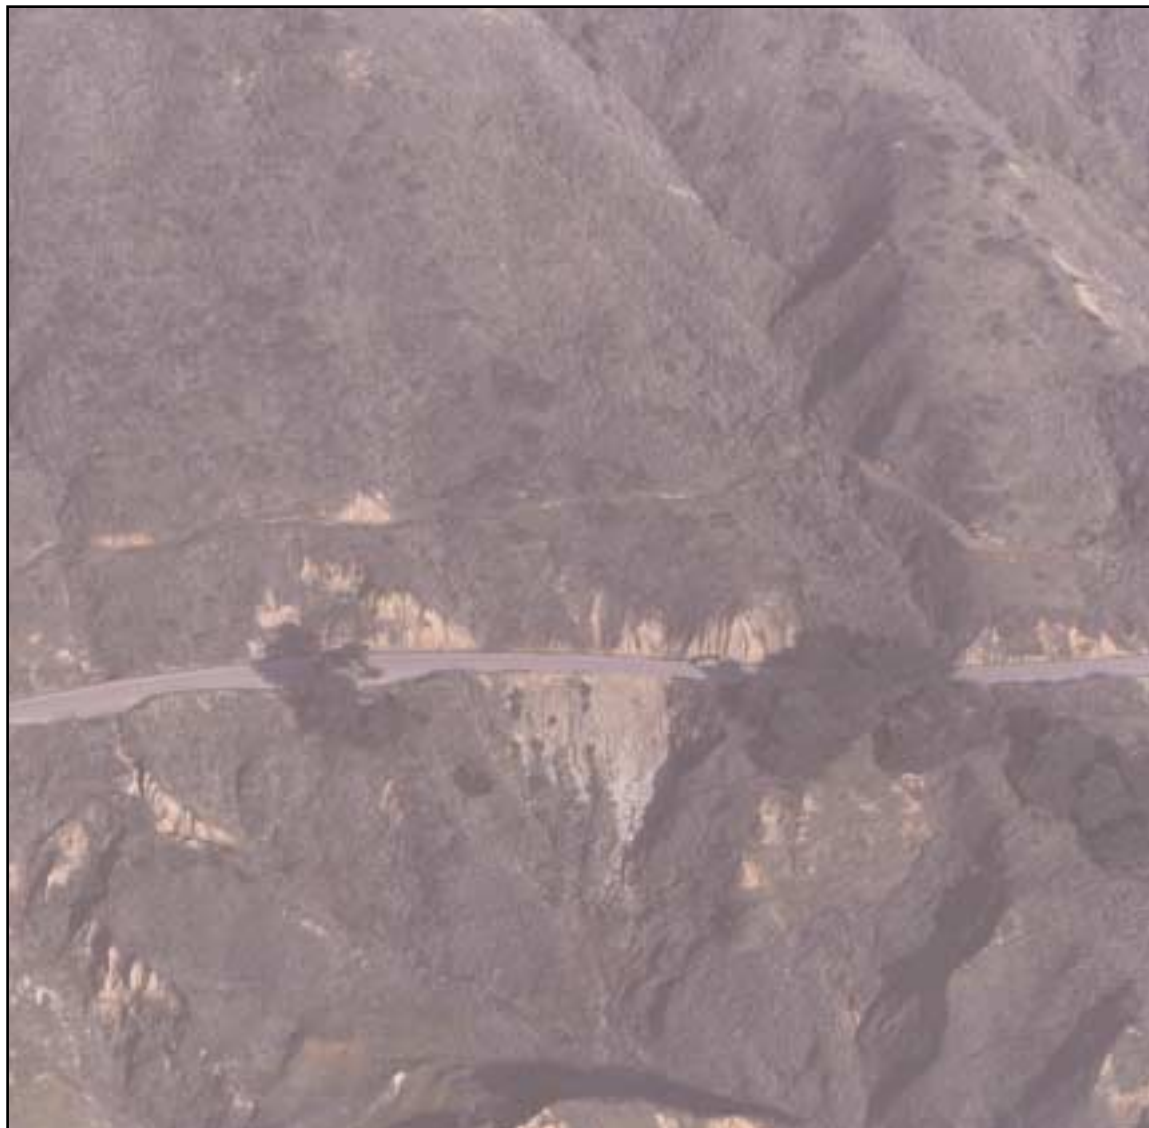
Figure 2.4. Little Sur South, February 2000.

Caltrans Erosion Site Analyses		Little Sur - south					
SLO County Line Mile Post Marker		55					
Photo-Reference Number							
Site Conditions		lack of vegetation below recently installed crib wall					
Habitat Type		Dune, bluff scrub					
Soil Type		sand stone, sand dune					
Slope		50%-60%					
Aspect		West					
Sensitive habitat present		Marine, <i>Arctostaphylos edmundsii</i>					
Regional and Neighboring Property Owners		Jim Hill					
Potential Occurrence of Rare Plant and Animal Species							
<i>Eriogonum parvifolium</i>							
Smith's blue butterfly							
<i>Arctostaphylos edmundsii</i>							
Exotic Species Present (threat)		iceplant					
Potential Occurrence of Cultural Artifacts							
none							
		Importance					
		Urgency					
		Trend					
POTENTIAL FOR EROSION EVENT		(rank 1-10)	up slope down slope up slope down slope up slope down slope				
Erosion Hazard		0	8	0	2	0	2
Potential slope failure		0	4	0	2	0	2

Baren soil surface rill and gully erosion present		0	8	0	2	0	2
Baren soil surface (temporary stockpiling)		0	0	0	0	0	0
Potential impacts to sensitive habitat		0	2	0	2	0	8
Potential impacts to engineered drainage and/or conveyance structure		0	2	0	2	0	2
Potential erosion control device (treatment) failure		0	2	0	2	0	2
Drainage problem source		0	2	0	2	0	2
Exotic species invasions		0	6	0	8	0	8
Revegetation		0	6	0	8	0	8
TOTAL		0	40	0	30	0	36

Site # 4 Little Sur South					
Site Objective	Erosion Control/ Revegetation	Bio-Engineering Applications	Restoration Recommendations		
			Site Maintenance Actions	Seed and Revegetation	Monitoring Actions
Site Stabilization			Redirect surface water flow across highway	<i>Lupinus albifrons, Festuca rubra, Erigeron glaucus</i>	
			Rill and gully erosion repair downslope		Is site stable?
Revegetation	Hydroseed south flank of downslope		Once surface water flow redirected, hydroseed	Plant willow at toe of downslope	Is site vegetated with a diversity of species present?
	Plant cypress trees to stabilize soils				
Site Maintenance	Downslope exotic species present: kikuya grass		Control of exotic species	Vegetate berms with low growing annuals or perennial grasses	Monitor cracks in pavement
					Are exotic invasive plant species less than 10% of site coverage?
Project Reporting	No erosion present		Site maintenance actions recorded	Submittals review/ specified materials at hand	Project completed, success criteria achieved-Final Recommendations

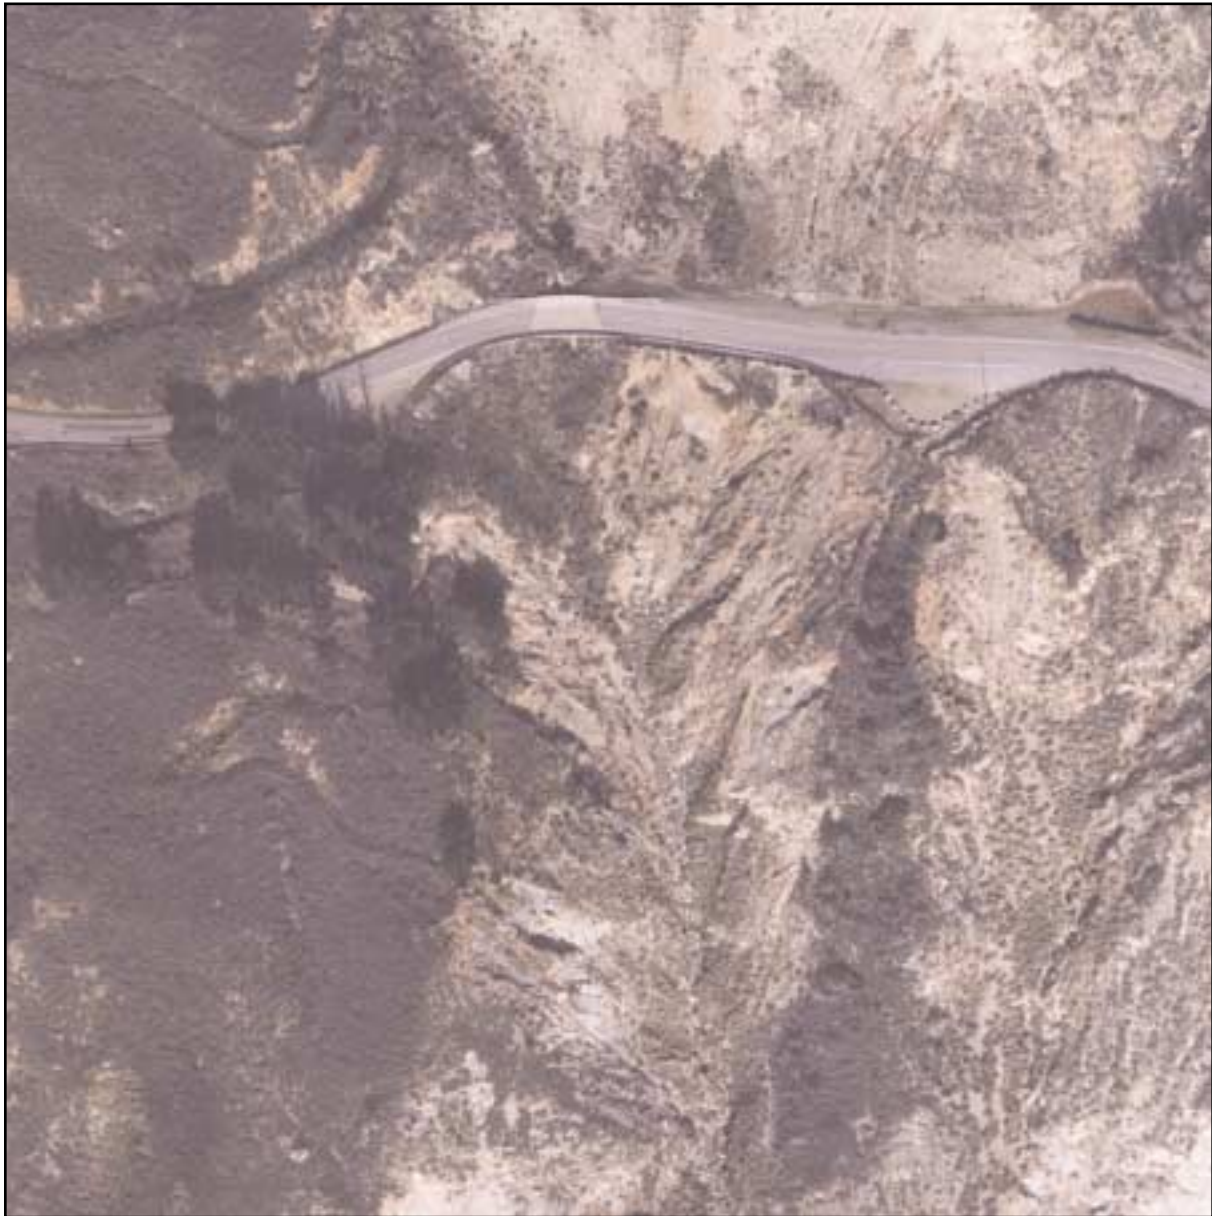
Figure 2.7. Sycamore Draw, February 2000.

Caltrans Erosion Site Analyses		Sycamore Draw					
SLO County Line Mile Post Marker	39						
Photo-Reference Number	1-01, 1-02						
Site Conditions	eroding slope, debris eroding near bridge structure, 10 acres of broom, pampas, some fennel						
Habitat Type	Central Coast Scrub						
Soil Type	Bedrock and landslide debris						
Slope	85%						
Aspect	West/Southwest						
Sensitive habitat present	Smith's blue						
Regional and Neighboring Property Owners	Pat Billig, Jeremy Wilson, USFS						
Potential Occurance of Rare Plant and Animal Species							
Riparian draws, Red-legged frog, Sea otter habitat, intertidal animals threatned by erosion							
Smith's blue butterfly							
Eriogonum parvifolium							
Exotic Species Present (threat)							
Pennisetum clandestinum, Foeniculum vulgare, Genista monspessulanna, Centaria melitensis,							
Potential Occurance of Cultural Artifacts							
Skinner Peirce body, native American midden off-site USFS

Importance		Urgency		Trend	
<u>POTENTIAL FOR EROSION EVENT</u>	<u>[rank 1-10]</u>	<u>up slope</u>	<u>down slope</u>	<u>up slope</u>	<u>down slope</u>	<u>up slope</u>	<u>down slope</u>
Erosion Hazard		6	4	8	3	3	2
Potential slope failure		0	0	0	0	0	0
Baren soil surface rill and gully erosion present		8	3	8	3	8	5
Baren soil surface (temporary stockpiling)		7	2	9	2	9	2
Potential impacts to sensitive habitat		5	2	2	0	2	0
Potential impacts to engineered drainage and/or conveyance structure		5	2	8	2	3	2
Potential erosion control device (treatment) failure		7	2	7	2	7	2
Drainage problem source	Attempted drainage failed	0	0	0	0	0	0
Exotic species invasions		2	9	2	9	2	9
Revegetation		7	3	6	4	6	3
TOTAL		47	27	50	25	40	25

Site #5 Sycamore Draw					
Restoration Recommendations					
Site Objective	Erosion Control/ Revegetation	Bio-Engineering Applications	Site Maintenance Actions	Seed and Revegetation	Monitoring Actions
Site Stabilization			Rill and gully erosion repaired		Is site stable?
	Anchor toe of slope where slippage occurs downslope		Control surface water flow from upslope side of highway-prevent discharge under guard rail through non-controlled structure	<i>Elymus glaucus</i> , <i>Eriophyllum</i> <i>steachadifloium</i> , <i>Eriogonum</i> <i>parvifolium</i> , <i>Bromus</i> <i>carinatus</i> , <i>Lotus purshianus</i>	Monitor headcuts of slope under guard rail.
Revegetation		Willow pole cuttings in seeps and springs downslope		Hydroseed upslope. Apply straw downslope to protect surface.	Is site revegetated with a diversity of species present?
Site Maintenance	Stabilize cut on downslope of road		Exotic control: Fennel, Pampas grass, Genista downslope		Are all non-biodegradable elements removed?

Plug willows at base of cut				Are exotic invasive plant species less than 10% of site coverage?
Project Reporting	No erosion present		Site maintenance actions recorded	Submittals review/ specified materials at hand	Project completed, success criteria achieved-Final Recommendations
	Erosion present/ recommendations			Specified materials not available/ specify alternates	Project not completed-remedial measures required

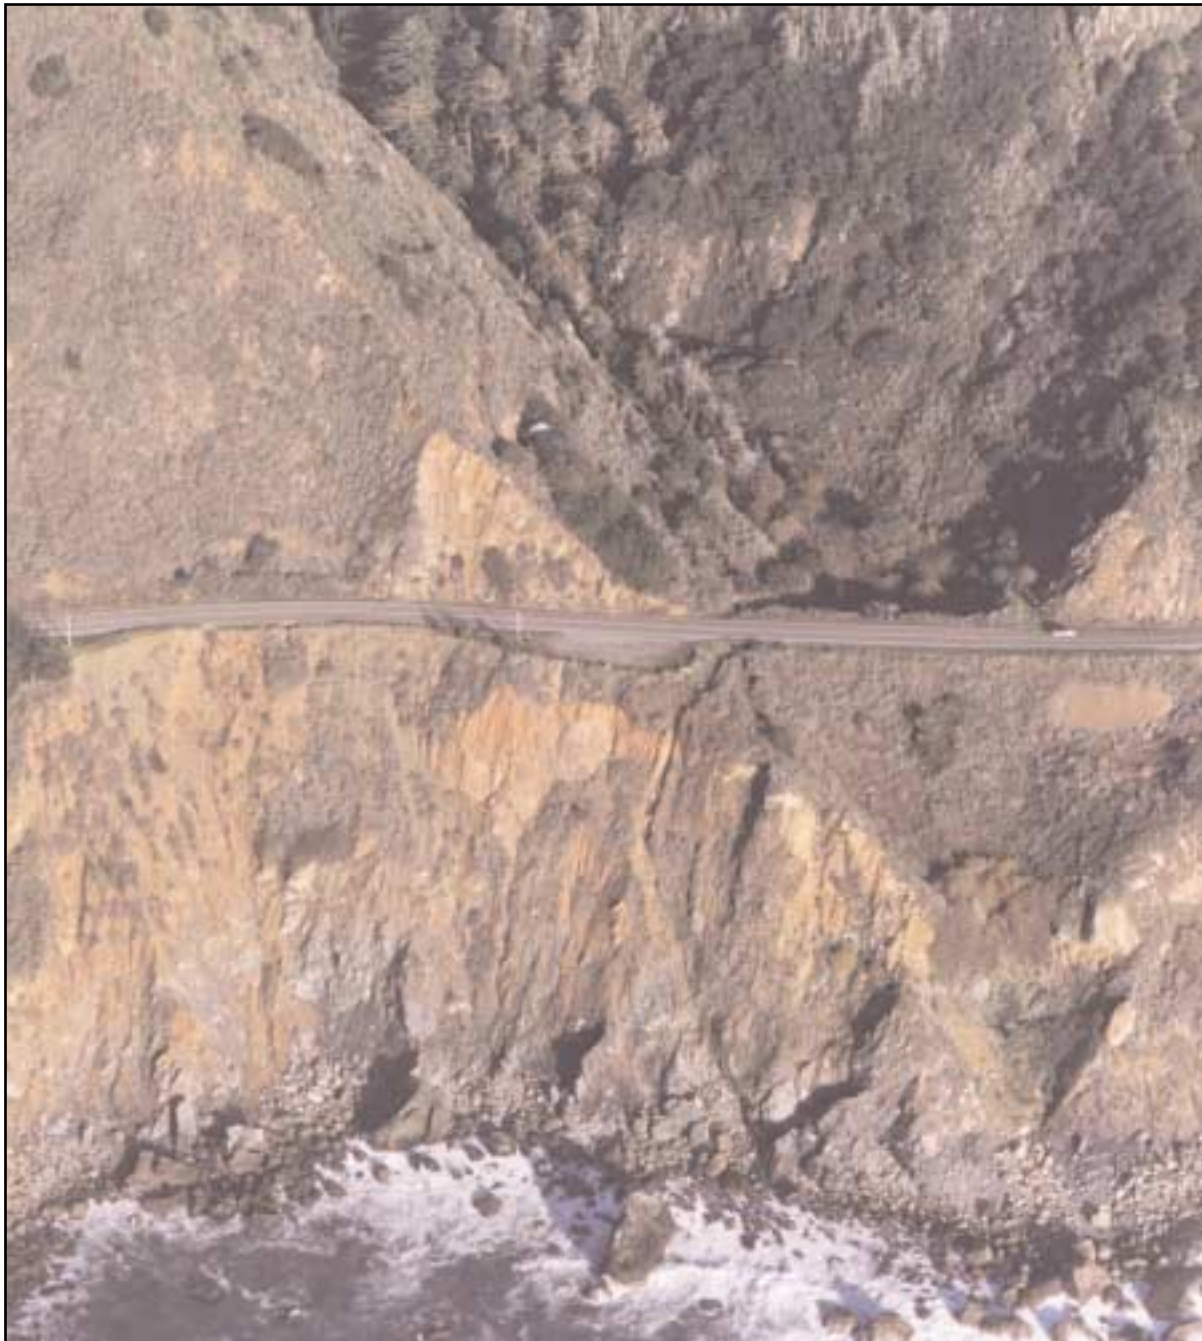
Figure 2.11. Rat Creek, February 2000.

Caltrans Erosion Site Analyses		Rat Creek					
SLO County Line Mile Post Marker		30.2					
Photo-Reference Number		2-01, 2-02					
Site Conditions		slumping downslope, road bank failure					
Habitat Type		Central Coast Scrub					
Soil Type		Decomposed granite					
Slope		50-60%					
Aspect		Southwest					
Sensitive habitat present		Smith's blue					
Regional and Neighboring Property Owners		Jack O'Neil, Big Creek Reserve					
Potential Occurance of Rare Plant and Animal Species							
Smith's blue butterfly							
Eriogonum parvifolium							
Exotic Species Present (threat)							
Pennisetum clandestinum, Foeniculum vulgare, Genista monspessulana							
Potential Occurance of Cultural Artifacts							
none							
		Importance		Urgency		Trend	
<u>POTENTIAL FOR EROSION EVENT</u>		<u>(rank 1-10)</u>		<u>up slope</u>	<u>down slope</u>	<u>up slope</u>	<u>down slope</u>
Erosion Hazard		10	3	0	3	0	3
Potential slope failure		10	0	0	1	0	3

Baren soil surface rill and gully erosion present		1	3	0	3	2	5
Baren soil surface (temporary stockpiling)		0	0	0	0	0	0
Potential impacts to sensitive habitat		0	2	0	2	0	3
Potential impacts to engineered drainage and/or conveyance structure		0	2	0	2	0	3
Potential erosion control device (treatment) failure		(treatment failure)	0	0	0	0	0
Drainage problem source		Attempted drainage failed	0	0	0	0	0
Exotic species invasions			0	2	0	1	0
Revegetation			0	4	0	3	0
TOTAL			21	16	0	15	2

Site Objective	Revegetation	Applications	Actions	Revegetation
Site Stabilization			Redirect water flow from upslope side of highway to control structure Rill and gully erosion repaired downslope	<i>Salix stiche</i> <i>Eriophylla</i> <i>staechadifolia</i> <i>Eriogonum parviflorum</i> <i>Melica imrayana</i>
Revegetation	Hydroseed upslope with perennial mix		After kikuya grass controlled, hydroseed downslope	Hydroseed upslope perennial
Site Maintenance			Control exotic species- Pampas grass, fennel, and kikuya grass	
Project Reporting	No erosion present		Site maintenance actions recorded	Submittals re specified materials hand

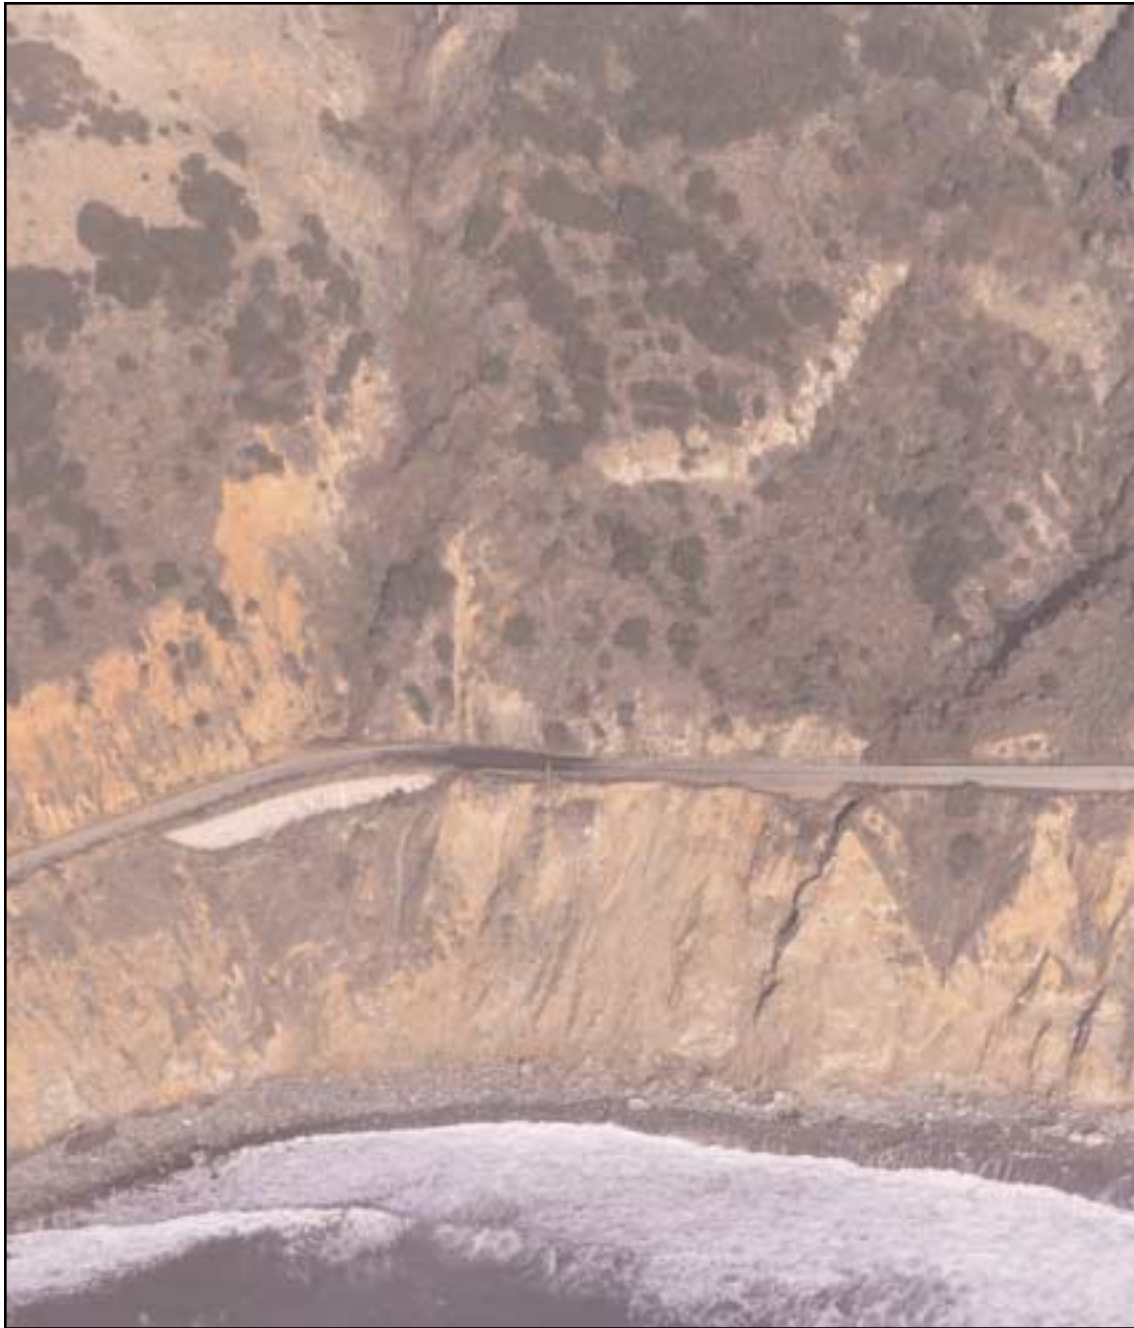
Figure 2.14. Vista Point South Big Creek, February 2000.

Caltrans Erosion Site Analyses		Vista Point south of Big Creek						
SLO County Line Mile Post Marker		27.5						
Photo-Reference Number		12-01, 12-02, 12-03, 12-04, 12-05						
Site Conditions		overcast slumping down to beach, exposed telephone cable, slump in road, headcut of canyon up to highway edge						
Habitat Type		Central Coast Scrub						
Soil Type		Franciscan , decomposed conglomerate						
Slope		60%						
Aspect		Northwest						
Sensitive habitat present		Marine						
Regional and Neighboring Property Owners		Big Creek Reserve						
Potential Occurance of Rare Plant and Animal Species								
Eriogonum parvifolium								
Smith's blue butterfly								
Exotic Species Present (threat)								
Cortaderia jubata, Foeniculum vulgare								
Potential Occurance of Cultural Artifacts								
none								
<u>POTENTIAL FOR EROSION EVENT</u>		<u>(rank 1-10)</u>	<u>Importance</u>		<u>Urgency</u>		<u>Trend</u>

<u>up slope</u>	<u>down slope</u>	<u>up slope</u>	<u>down slope</u>	<u>up slope</u>	<u>down slope</u>
Erosion Hazard			0	8	0	8	0	8
Baren soil surface rill and gully erosion present			0	8	0	6	0	8
Baren soil surface (temporary stockpiling)			0	2	0	6	0	8
Potential impacts to sensitive habitat			0	2	0	2	0	8
Potential impacts to engineered drainage and/or conveyance structure			0	4	0	2	0	8
Potential erosion control device (treatment) failure		(treatment failure)	0	8	0	8	0	2
Drainage problem source		Attempted drainage failed	0	0	0	0	0	2
Exotic species invasions			0	4	0	2	0	6
Revegetation			0	9	0	7	0	7
TOTAL			0	45	0	41	0	57

Site # 9 Vista Point-South of Big Creek					
Site Objective	Restoration Recommendations				
	Erosion Control/ Revegetation	Bio-Engineering Applications	Site Maintenance Actions	Seed and Revegetation	Monitoring Actions
Site Stabilization			Erosion control gullies and rills repaired	<i>Mimulus auranticus</i> , <i>Ceanothus thrysiflorus</i> , <i>Artemisia californica</i> , <i>Briklia californica</i> , <i>Stachys bulata</i>	Site stabilized, erosion present?
	Site requires permanent revegetation				
Revegetation			Reseeding, planting as required - Hydroseed downslope	Revegetate with permanent vegetation on berms	Is site revegetated, species diversity present?
Site Maintenance	Exotic species present: Pampas grass- fennel		Control of exotic species		Weeds controlled, exotic species less than 10% cover
					Non bio-degradable items removed
					Are exotic invasive plant species less than 10% of site coverage?

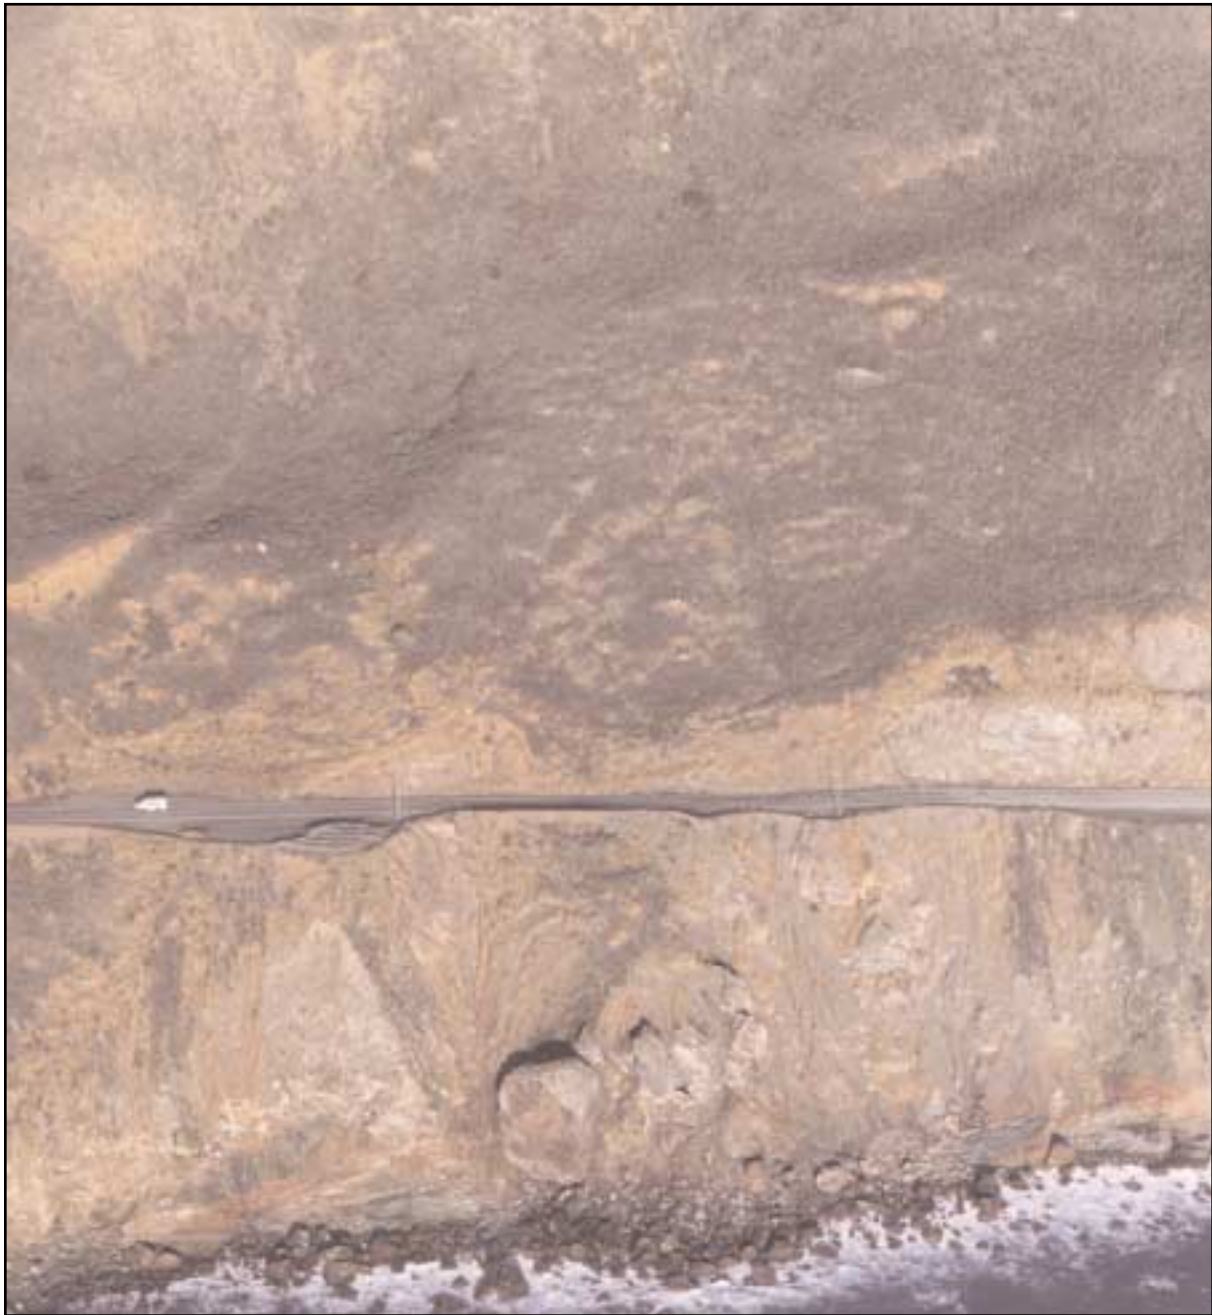
Figure 2.18. North Vicente Creek Bridge, February 2000.

Caltrans Erosion Site Analyses		North Vicente Creek Bridge					
SLO County Line Mile Post Marker	26.2						
Photo-Reference Number	13-01, 13-02, 13-03						
Site Conditions	Highway slumping, overcast soils, no weed control, soil flowing to intertidal zone, phone cable impact						
Habitat Type	Coast scrub						
Soil Type	Decomposed granite						
Slope	40%						
Aspect	West						
Sensitive habitat present	Smiths blue butterfly						
Regional and Neighboring Property Owners	Packard Ranch						
Potential Occurance of Rare Plant and Animal Species							
Eriogonum parvifolium							
Smith's blue butterfly							
Exotic Species Present (threat)							
Foeniculum vulgare, Cotaderia jubata, Silybium marianum							
Potential Occurance of Cultural Artifacts							
none							
<u>POTENTIAL FOR EROSION EVENT</u>		(rank 1-10)	Importance	Urgency	Trend		
			up slope	down slope	up slope	down slope	
Erosion Hazard			0	3	0	3	6

Potential slope failure			0	8	0	8	7
Baren soil surface rill and gully erosion present			0	5	0	5	5
Baren soil surface (temporary stockpiling)			0	8	0	8	7
Potential impacts to sensitive habitat			0	7	5	5	7
Potential impacts to engineered drainage and/or conveyance structure			0	8	0	5	5
Potential erosion control device (treatment) failure		(treatment failure)	0	2	0	2	2
Drainage problem source		Attempted drainage failed	0	0	0	0	0
Exotic species invasions			0	7	0	5	5
Revegetation			3	6	0	5	5
TOTAL			3	54	5	46	49

Site #10 North Vicente Creek Bridge					
Restoration Recommendations					
Site Objective	Erosion Control/ Revegetation	Bio-Engineering Applications	Site Maintenance Actions	Seed and Revegetation	Monitoring Actions
Site Stabilization		Hydroseed and straw	Manage sidecast- Remove material that is piled over two feet high	<i>Mimulus auranticus,</i> <i>Ceanothus thyrsiflorus,</i> <i>Artemisia californica,</i> <i>Bacharris pilularis, Lupinus albafrons</i>	Site stabilized, erosion present?
Revegetation	Upslope requires permanent revegetation mix		Reseeding, planting as required Site requires temporary erosion control on berms		Is site revegetated, species diversity present?
Site Maintenance	Exotic species present: Pampas grass- fennel		Control of exotic species Surface water diversion treatment needed immediately		Weeds controlled, exotic species less than 10% cover
Project Reporting	Required as project element	Report	Site maintenance actions recorded	Submittals review/ specified materials at hand Specified materials not available/ specify alternates	Project completed/success criteria achieved Project not completed- remedial measures required

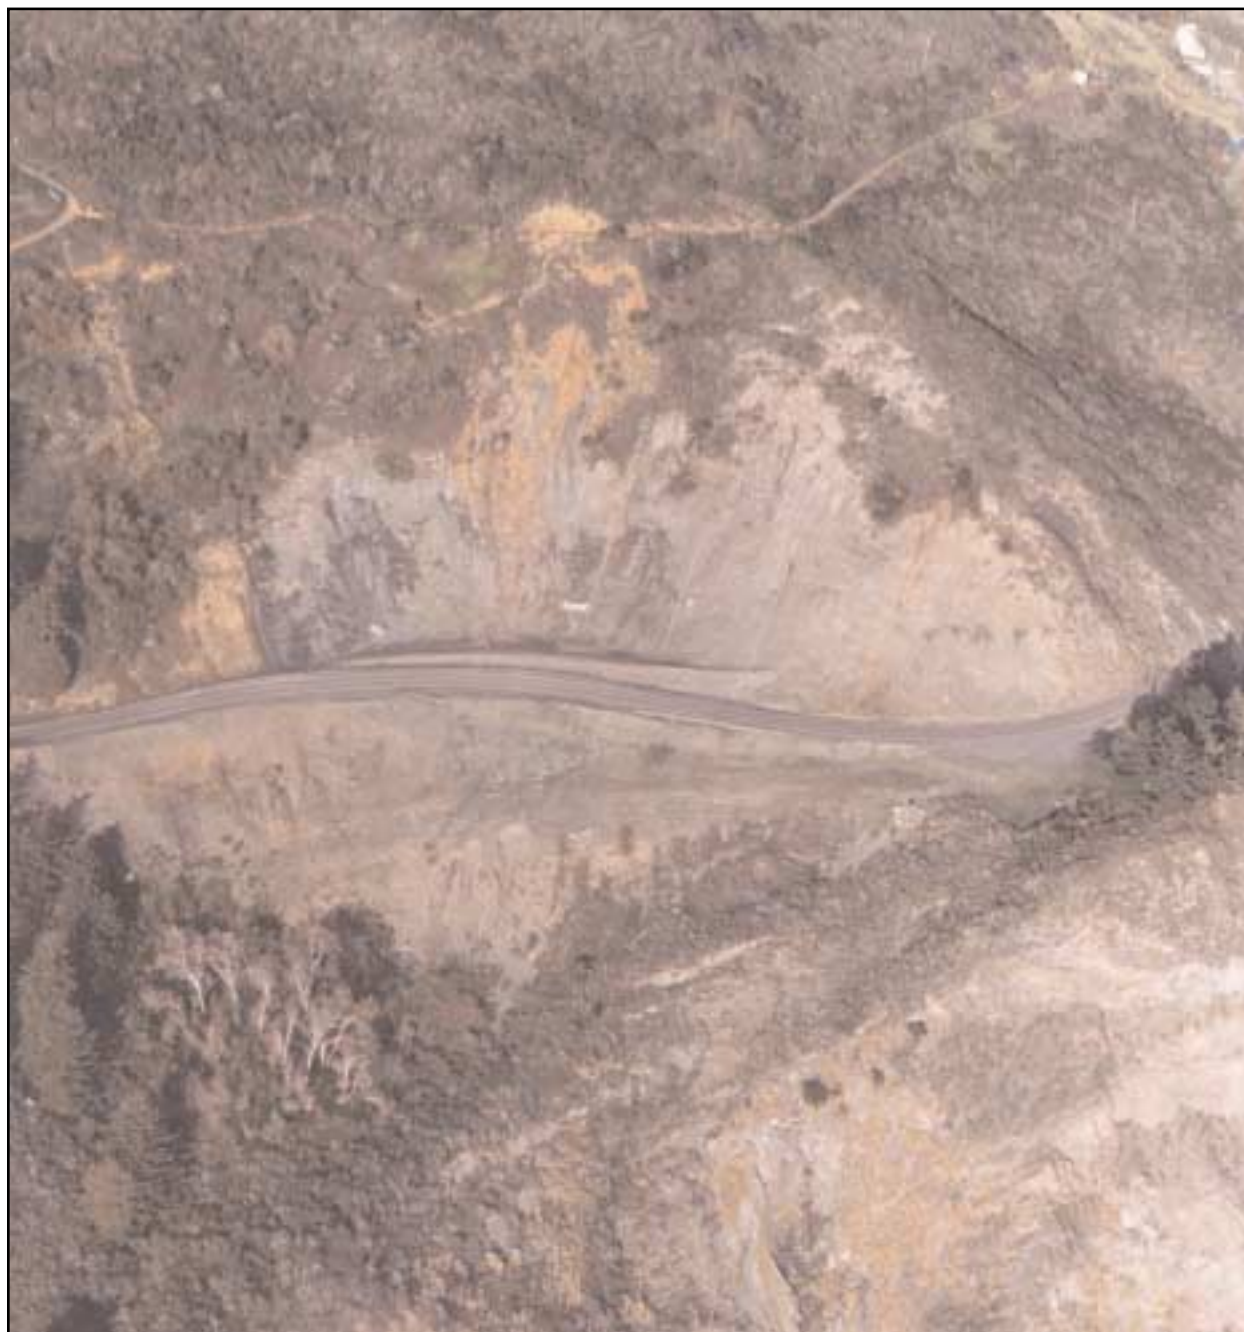
Figure 2.22. Grandpa's Elbow, February 2000.

Caltrans Erosion Site Analyses		Grandpa's Elbow							
SLO County Line Mile Post Marker		6.4							
Photo-Reference Number		3-01, 3-02, 3-03, 3-04							
Site Conditions		slumping upslope, side cast downslope, no bedrock visible							
Habitat Type		Redwood fringe, Ceanothus scrub, coastal scrub							
Soil Type		serpentine							
Slope		25%							
Aspect		West							
Sensitive habitat present		Riparian on north side							
Regional and Neighboring Property Owners		John Harlan, Provost							
Potential Occurance of Rare Plant and Animal Species									
Red-legged frog									
Smith's blue butterfly									
Eriogonum parvifolium									
Exotic Species Present (threat)									
Cortaderia jubata, Genista monspessulanna, Senecio mikanioides									
Potential Occurance of Cultural Artifacts									
historic structures on Harlan point									
<u>POTENTIAL FOR EROSION EVENT</u>		(rank 1-10)		Importance		Urgency		Trend

up slope down slope		up slope down slope		up slope down slope	
Erosion Hazard		2 4		2 3		2 2		2 2	
Potential slope failure		2 3		4 6		4 4		5 5	
Baren soil surface rill and gully erosion present		1 3		1 5		2 2		5 5	
Baren soil surface (temporary stockpiling)		3 2		2 2		2 2		2 2	
Potential impacts to sensitive habitat		4 4		3 5		5 3		5 5	
Potential impacts to engineered drainage and/or conveyance structure		2 1		2 1		2 2		1 1	
Potential erosion control device (treatment) failure		0 0		0 0		0 0		0 0	
Drainage problem source		0 0		0 0		0 0		0 0	
Exotic species invasions		2 2		1 1		2 2		2 2	
Revegetation		3 3		3 3		3 3		3 3	
TOTAL		19 22		18 26		20 25

Site Objective	Erosion Control/ Revegetation	Bio-Engineering Applications	Site Maintenance Actions	Seed and Revegetation	Monitoring Actions
Site Stabilization	Continue remedial erosion control seeding upslope		Rill and gully erosion repaired	<i>Melica imperfecta</i> , <i>Festuca rubra</i> , <i>Lotus purshianus</i> , <i>Festuca californica</i> , <i>Trifolium gracilentum</i>	Is site stable?
	Anchor toe of slope where slippage occurs downslope		Control surface water flow away from downslope into control structure.		Is erosion present?
Revegetation		Willow pole cuttings in seeps and springs up and down slope		Plant willow poles in wet seeps Plant <i>Eriogonum parvifolium</i> at 48"O.C. revegetation seed mix	Is site revegetated with a diversity of species present?
Site Maintenance		Repair/replace straw wattles upslope	Dry water installation needs to be removed	Use of hydropost top soiling required	Are all non-biodegradable elements removed?

There has been an approx. 35% loss of wattles upslope this year due to surface water damage.	Wooden stakes need removal Weed control: Fennel and Pampus grass		Are exotic invasive plant species less than 10% of site coverage?
Project Reporting	No erosion present	Bio-engineering in place and functioning	Site maintenance actions recorded	Submittals review/ specified materials at hand	Project completed, success criteria achieved-Final Recommendations
	Erosion present/ recommendations	Bio-engineering needs remedial repair and/or maintenance		Specified materials not available/ specify alternates	Project not completed-remedial measures required
